THE EFFECTS OF AN ALPINE FAULT  
EARTHQUAKE ON THE  
TARAMAKAU RIVER, SOUTH  
ISLAND, NEW ZEALAND

A thesis submitted in partial fulfilment of the  
requirements for the Degree  
of Master of Science  
at the University of Canterbury

by Mattilda Sheridan

2014

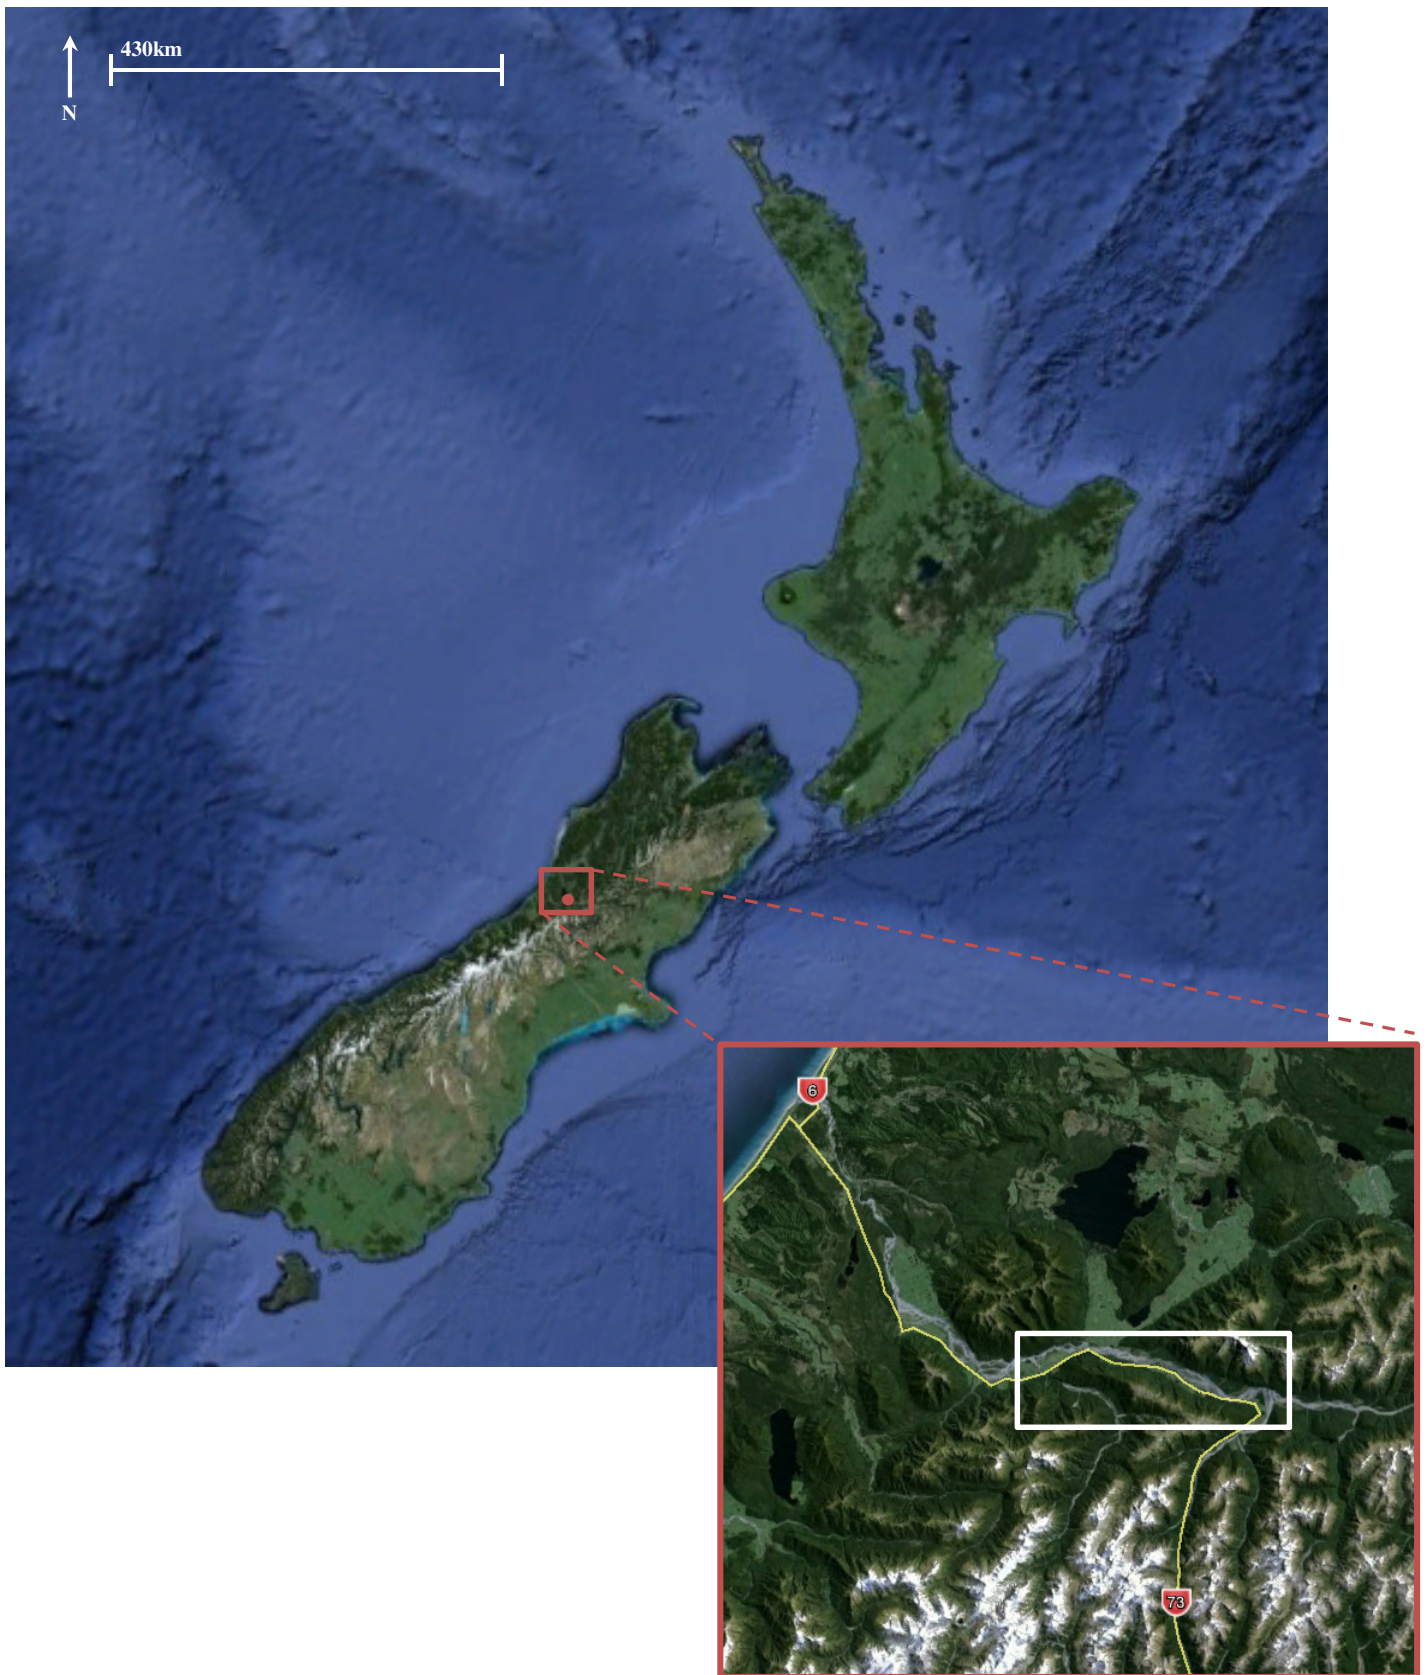
**Figure 1.1** Location of the Taramakau River in the Southern Alps of New Zealand. White box identifies study area. Base map sourced from Google Earth 2014.

The Taramakau River is a major alpine fluvial system, located in the northwest of the South Island in New Zealand (Figure 1.1). This river runs adjacent to State Highway 73 from Aickens to Kumara. The Taramakau River is crossed by the Alpine Fault near Inchbonnie, and runs parallel to the Hope Fault east of this. The study area for this project is the reach of the river that runs alongside State Highway 73 from Aickens to where the Taipo River meets the Taramakau River seven kilometres downstream of Inchbonnie.

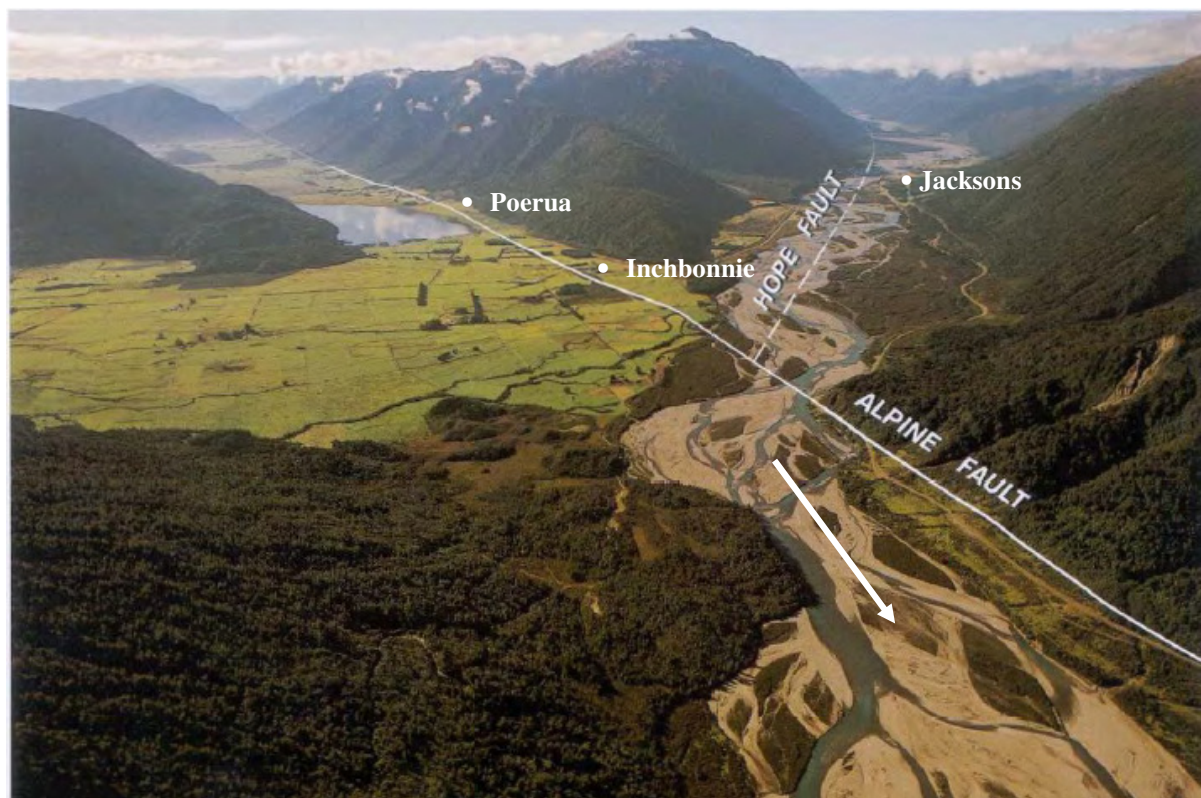
Figure 1.2b Trace of the Alpine Fault, obliquely cutting across the Taramakau River. White arrow indicates direction of flow. View looking east. Source Nathan et al (2002).

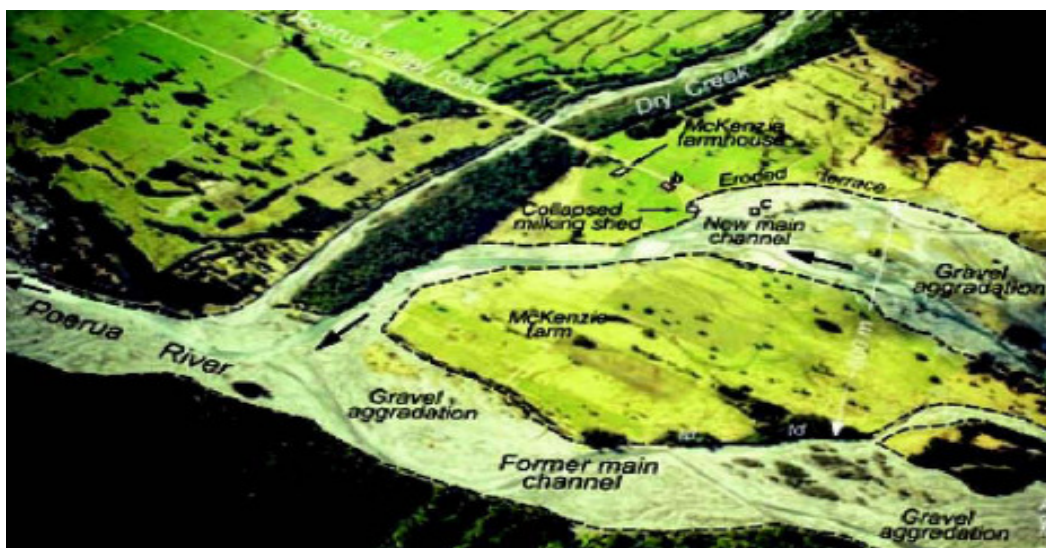
Figure 2.4 Poerua channel avulsion induced by gravel aggradation. The former channel shifted east towards the McKenzie farm, reactivating a previous channel of the Poerua River. Source Hancox et al (2005)

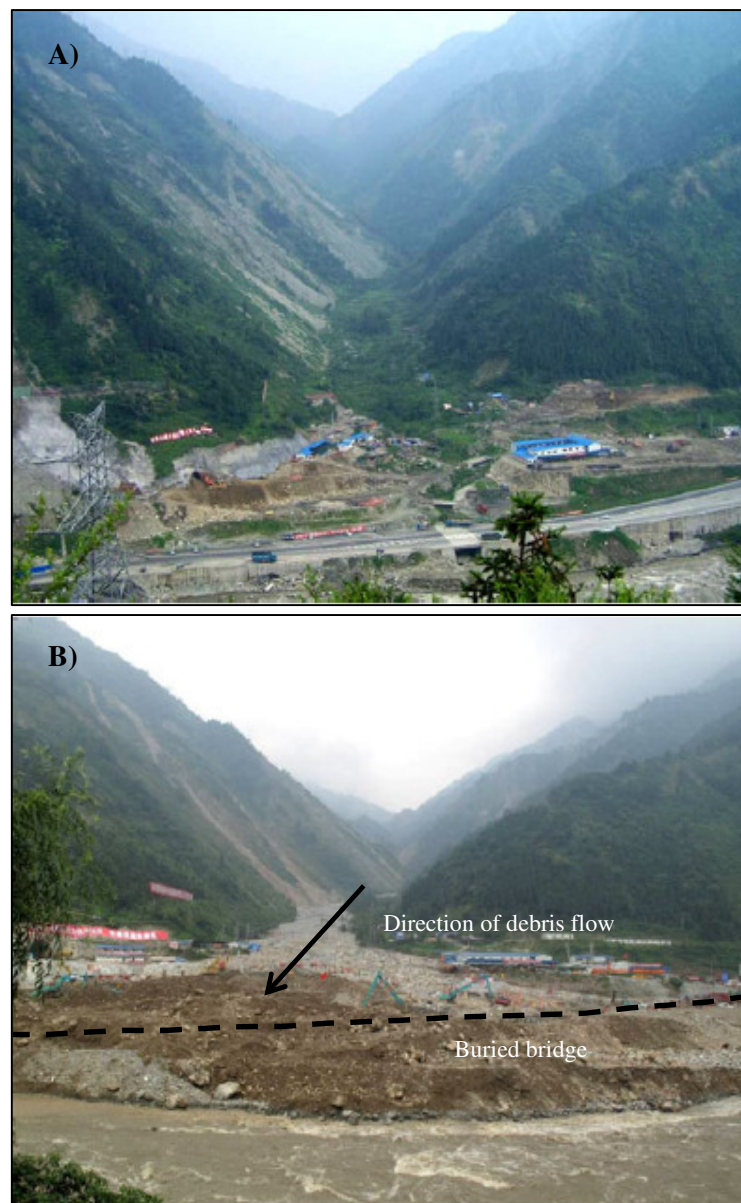
**Figure 2.6 Before and after the Wenchuan Earthquake. A) depositional fan with construction site (before), B) debris flow covering the fan, burying the road and impeding on the river (after). Source Tang et al (2011).**

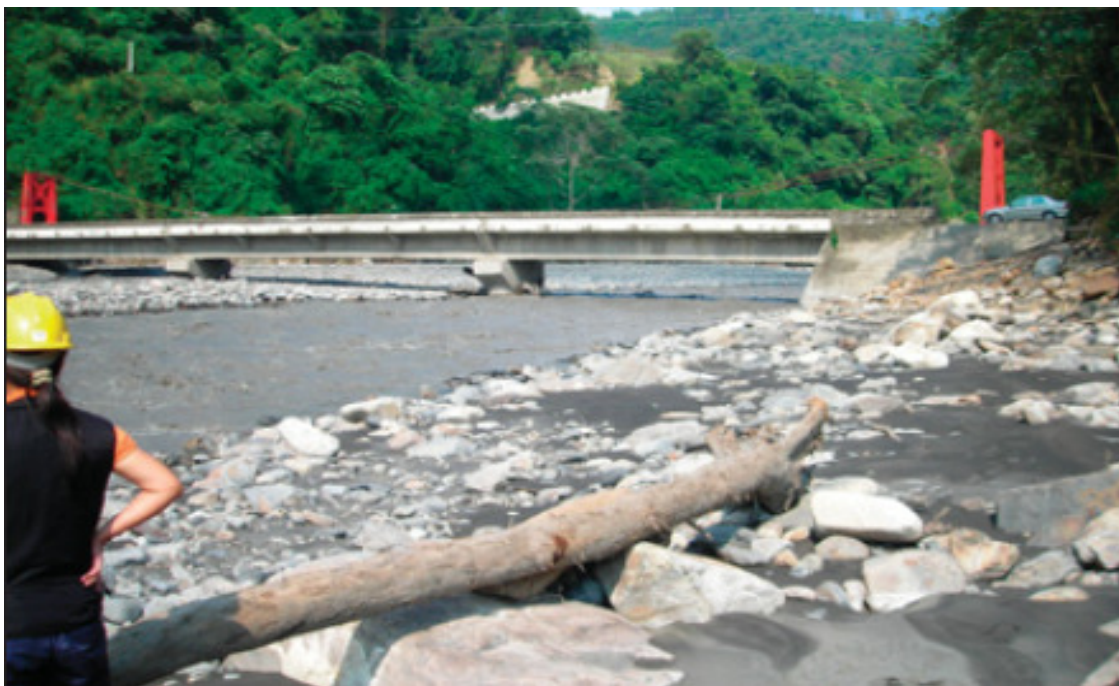
**Figure 2.7 Bridge piers that have almost completely been engulfed by Chi Chi earthquake derived sediment.**  
Source Yanities et al (2010).

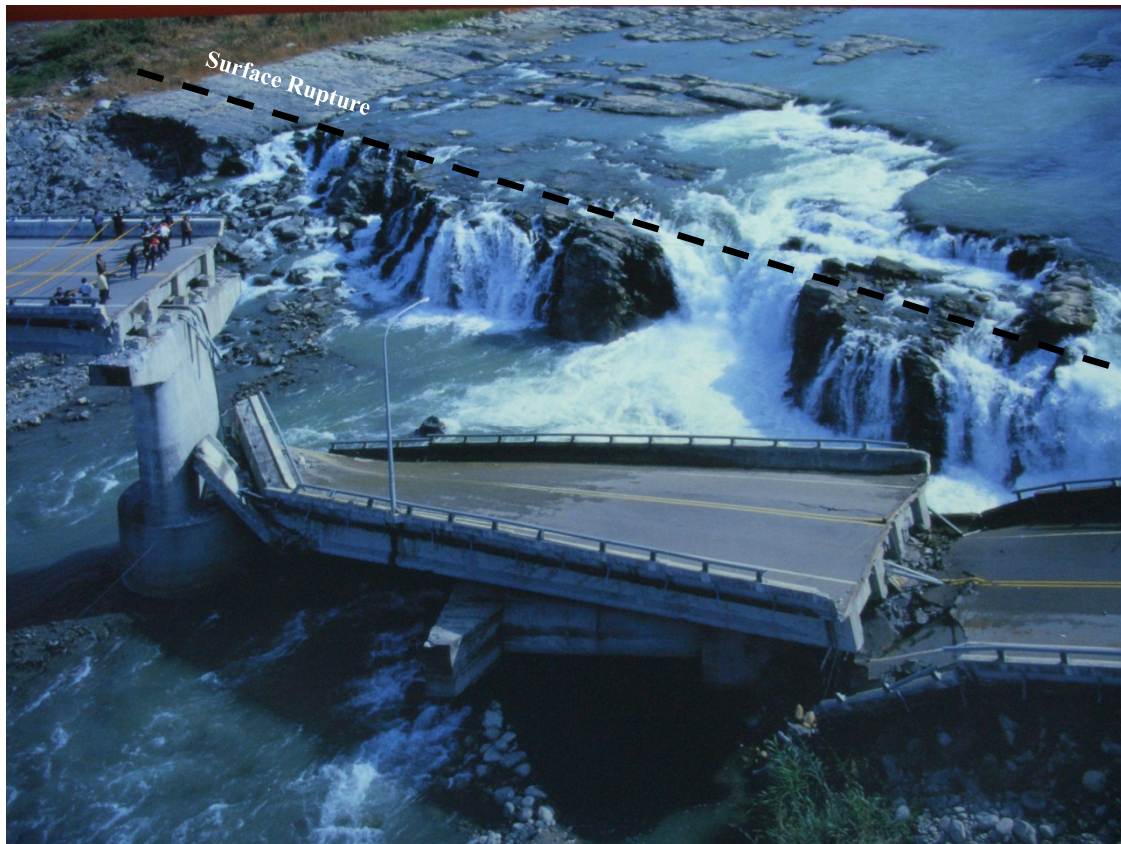
**Figure 2.8** Production of large river knickpoints from the surface rupture of the Chi Chi earthquake 1999. Clear damage to infrastructure and approximately five metres of vertical displacement to the river bed.  
*Pifeng Bridge*, n.d photograph, viewed 2 July 2014, < [http://www.geologie.geowissenschaften.uni-muenchen.de/archiv/taiwan\\_/index.html](http://www.geologie.geowissenschaften.uni-muenchen.de/archiv/taiwan_/index.html)>

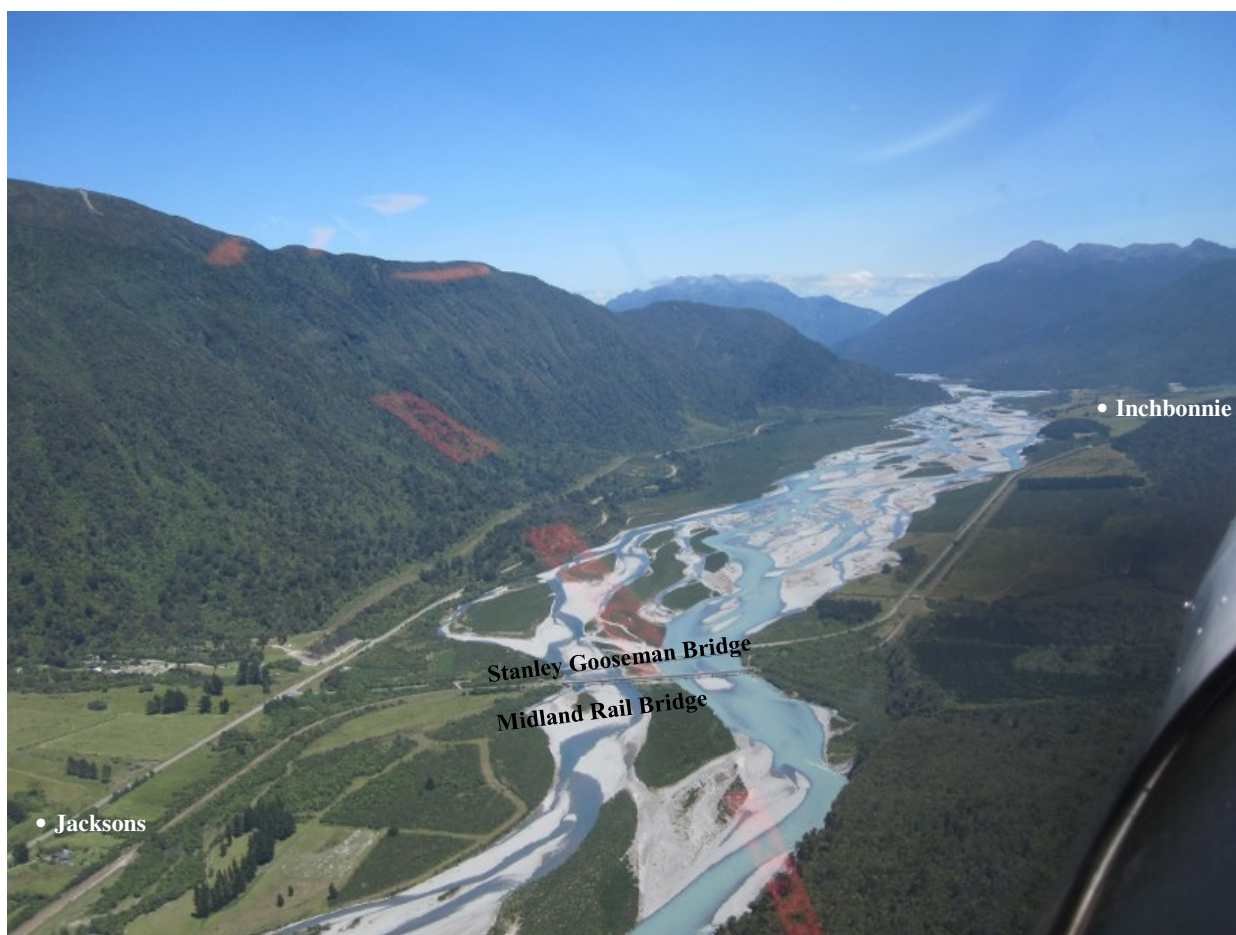
**Figure 5.1** Air photo of the Taramakau River near Jacksons. View looking west towards Hokitika. Photo taken in January 2013, approximately average flow rates ( $115 \text{ m}^3/\text{s}$ ). Channel flow does not occupy the entire river bed. *Taramakau Rail Bridge*, (2013) photograph viewed 1 August 2014, <<http://www.recwings.com/newsletters/2013/mar13/index.html>>

Chapter 5 presents the findings of aerial photographic interpretation. Aerial photograph analysis is a useful way to identify channel avulsions across active fluvial envelopes. Braided rivers are characterised by continual channel movement across the river bed. The Taramakau River bed is not fully occupied by channel flow (Figure 5.1); as with all braided rivers, the river beds are relatively wide containing networks of presently unoccupied channels. It is likely that many of these unoccupied channels will be reactivated by landslide-driven aggradation and avulsion following the next AFE. A series of aerial photographs has been collected and analysed using a stereoscope. The photographs date from 1943 and are held in the University of Canterbury's Geological Sciences Department collection. The aerial photographs cover the study area from Aickens to where the Taipo River meets the Taramakau.

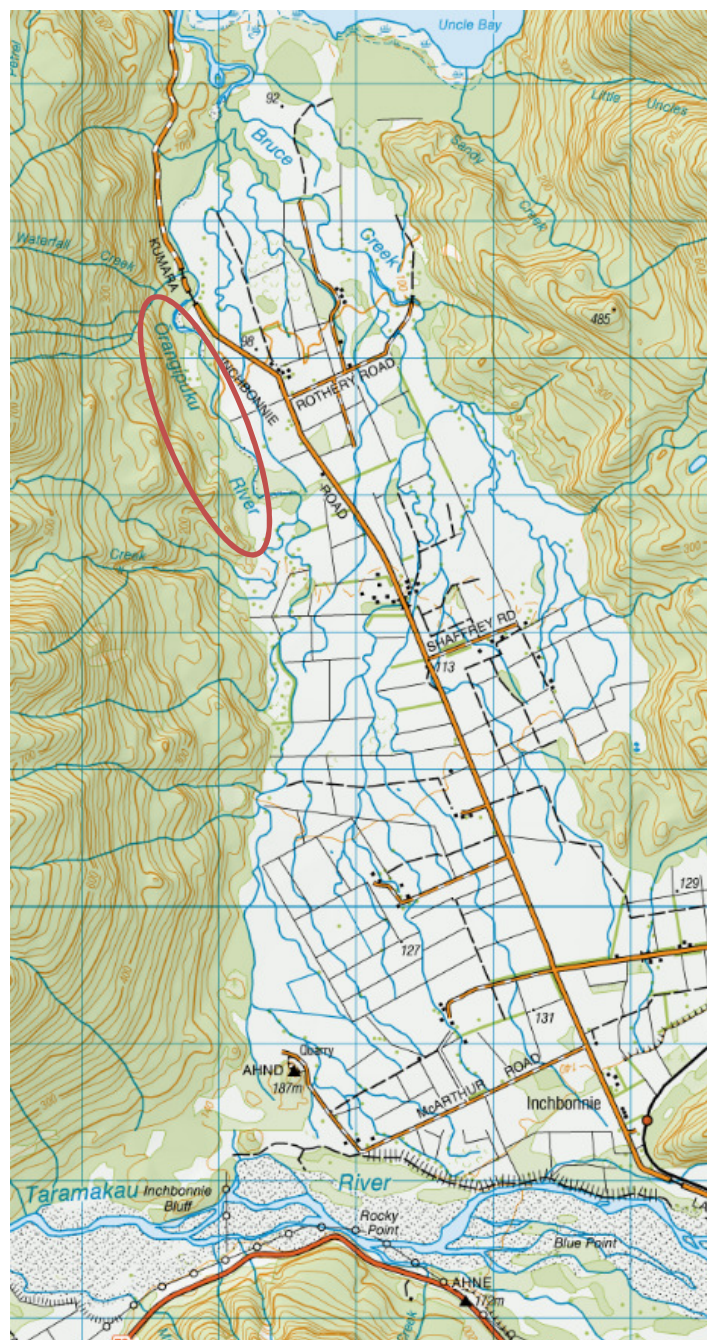
**Figure 5.10** Orangipuku River (circled) in the north and Taramakau River in the south. The Orangipuku River flowed parallel to the Taramakau prior to the 1940's. Lake Brunner lies north of the Orangipuku River. Base map sourced from Topo Map.

Of considerable concern is the hydraulic connection between the Orangipuku River and the Taramakau River (Figure 5.10). The Orangipuku River flows into Lake Brunner north of the study area. If Taramakau flow were to enter the Orangipuku River, the volume of water entering Lake Brunner would increase. An increased inflow into Lake Brunner would increase water flows in the Arnold River that flows out of Lake Brunner subsequently entering and inducing flooding in the Grey valley, further north of the study area. The possibility of hydraulic connection between the two rivers was recognised in the 1940's by the West Coast Regional Council. Prior to the 1940's the Orangipuku River ran parallel to the Taramakau River, flowing as close as five metres to the true right of the Taramakau River banks (WCRC, 2010).

To address hydraulic connection between the Taramakau and Orangipuku River, a stopbank was constructed along the true right of the Taramakau River. In 1959 an engineering report suggested the construction of a 2.5 km stopbank strengthening the existing 1.2 km stopbank. This proposal was approved and construction commenced in August 1959 (WCRC, 2010). Since completion of the stopbank the risk of hydraulic connection between the Taramakau and the Orangipuku River has decreased, evidenced by the shrinkage of the Orangipuku River (Figure 5.11a, b). Figure 5.11a is an aerial photograph taken in February of 1959, at this time the Orangipuku River flowed approximately 100 m north of the Taramakau River. The stopbank on the true right of the Taramakau River was strengthened six months after this photograph was taken. Figure 5.11b shows the current (2014) course of the Taramakau River and the Orangipuku River. From the LINZ photograph, the Orangipuku River has moved north and no longer flows parallel to the Taramakau River. The stopbank acts as a physical barrier between the two rivers diverting Taramakau channel flow away from the Orangipuku River. Since the strengthening of the stopbank in 1959, very few reports of the Taramakau spilling into the Orangipuku River have been recorded (WCRC, 2010). The stopbank has potentially minimised the threat of Taramakau flood flows entering the Grey valley through Lake Brunner via the Orangipuku River. An AFE, however, is very likely to damage or destroy this stopbank, allowing flood flows to reoccupy the extensive paleo channels recognised in Figure 5.11a.

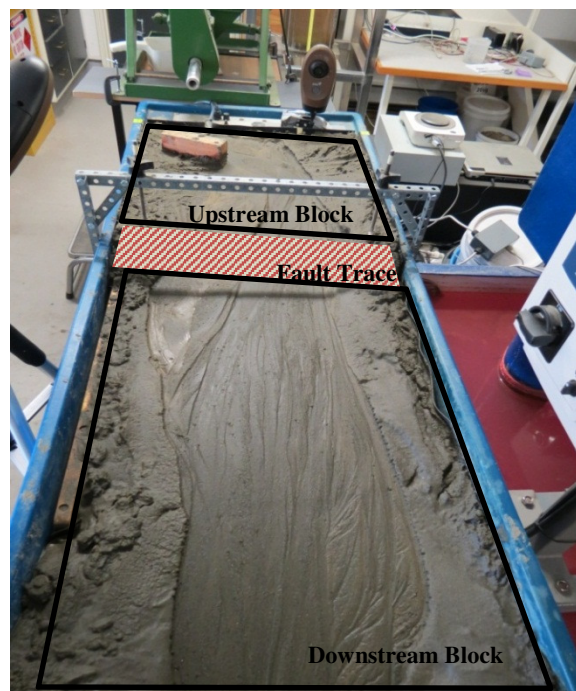
Figure 6.1 Stream board design. Upstream and downstream blocks are divided by a modelled fault trace.

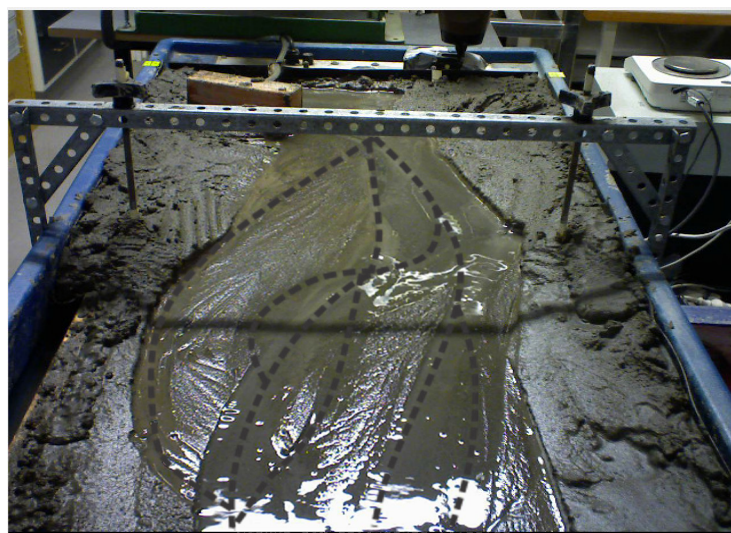
**Figure 6.3** Looking upstream of the micro-model four hours since flow commenced in Experiment I; a braided river formed, identified by the array of braids and multiple channels in the downstream block. The dashed lines indicate main channel flows.

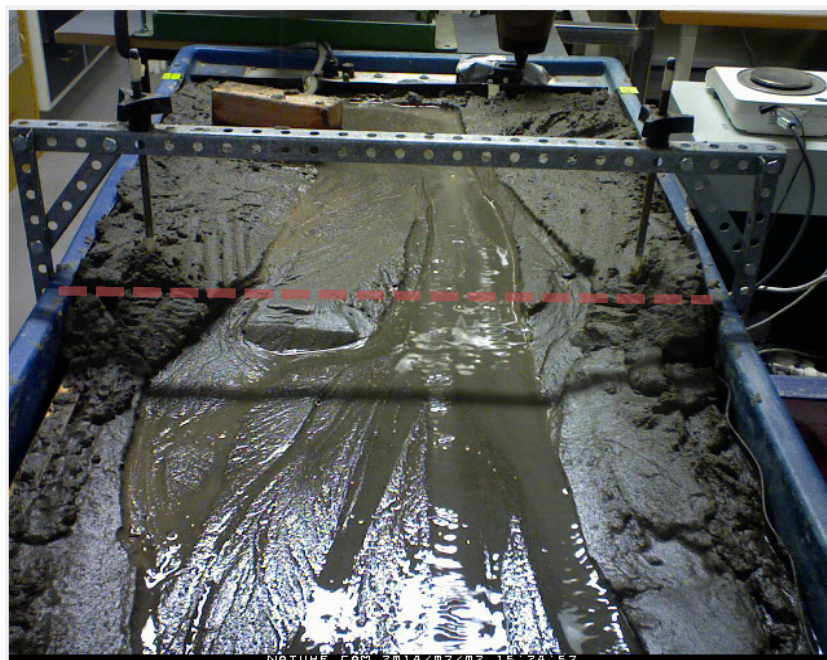
**Figure 6.7 Micro-scale model 1.5 hours after displacement in Experiment I, looking upstream. Downstream aggradation is favoured, and multiple channels have reformed. Scars from faulting are recognised by prominent elongate mid channel bars over the fault trace. Red dashed line marks the fault trace.**

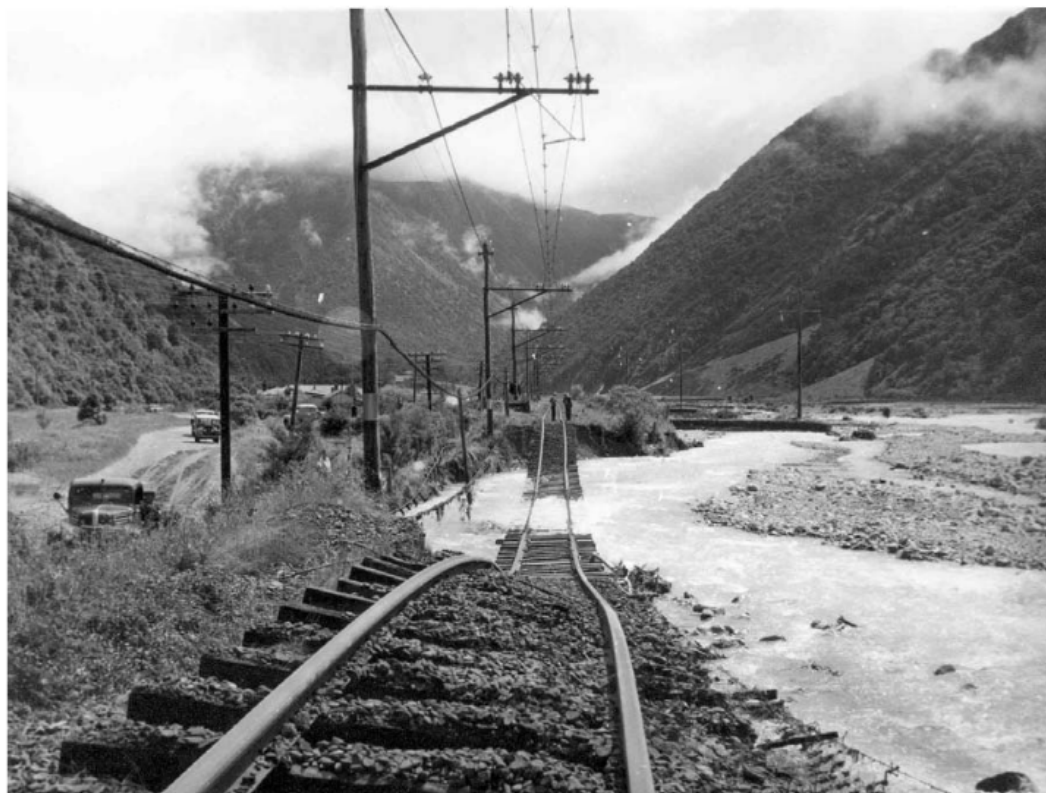
**Figure 7.7 Railway settlement in Otira undercut by Otira River channel avulsion (1950). Source History House Greymouth, WCRC (2002)**

Aerial photographic interpretation coupled with the findings of the micro-scale modelling experiments highlighted areas of high flood risk upstream of the fault. Aerial photograph interpretation showed that the Taramakau River since 1943 has gradually shifted north incising into the land around Inchbonnie threatening the road and rail by bank erosion and inundation. Briefly observed in all experiments of the micro-scale modelling was a phase of back pooling following vertical uplift, subsequently widening the floodplain and inducing sediment deposition. The reduction in slope upstream of the fault decreased the velocity of the channel flow as well as elevating the river bed. In the field, an elevated river bed together with aggradation and northward shifting channels may increase the risk of flooding upstream of the Alpine Fault, breaching natural levees and laterally spreading towards the road and rail transportation links between Inchbonnie and the Stanley Goosemen and Midland Rail Bridges. The river may also undercut the road and rail transportation routes resulting in the collapse of such structures as seen in Otira in 1950 (Figure 7.7).
